Green Lick Dam (NDI PA-219), Ohio River
Basin, Green Lick Run, Fayette County,
Pennsylvania. Phase I Inspection Report.

PHASE I REPORT
National Dam Inspection Program

Green Lick Dam

27 April 1978 (visual inspection)

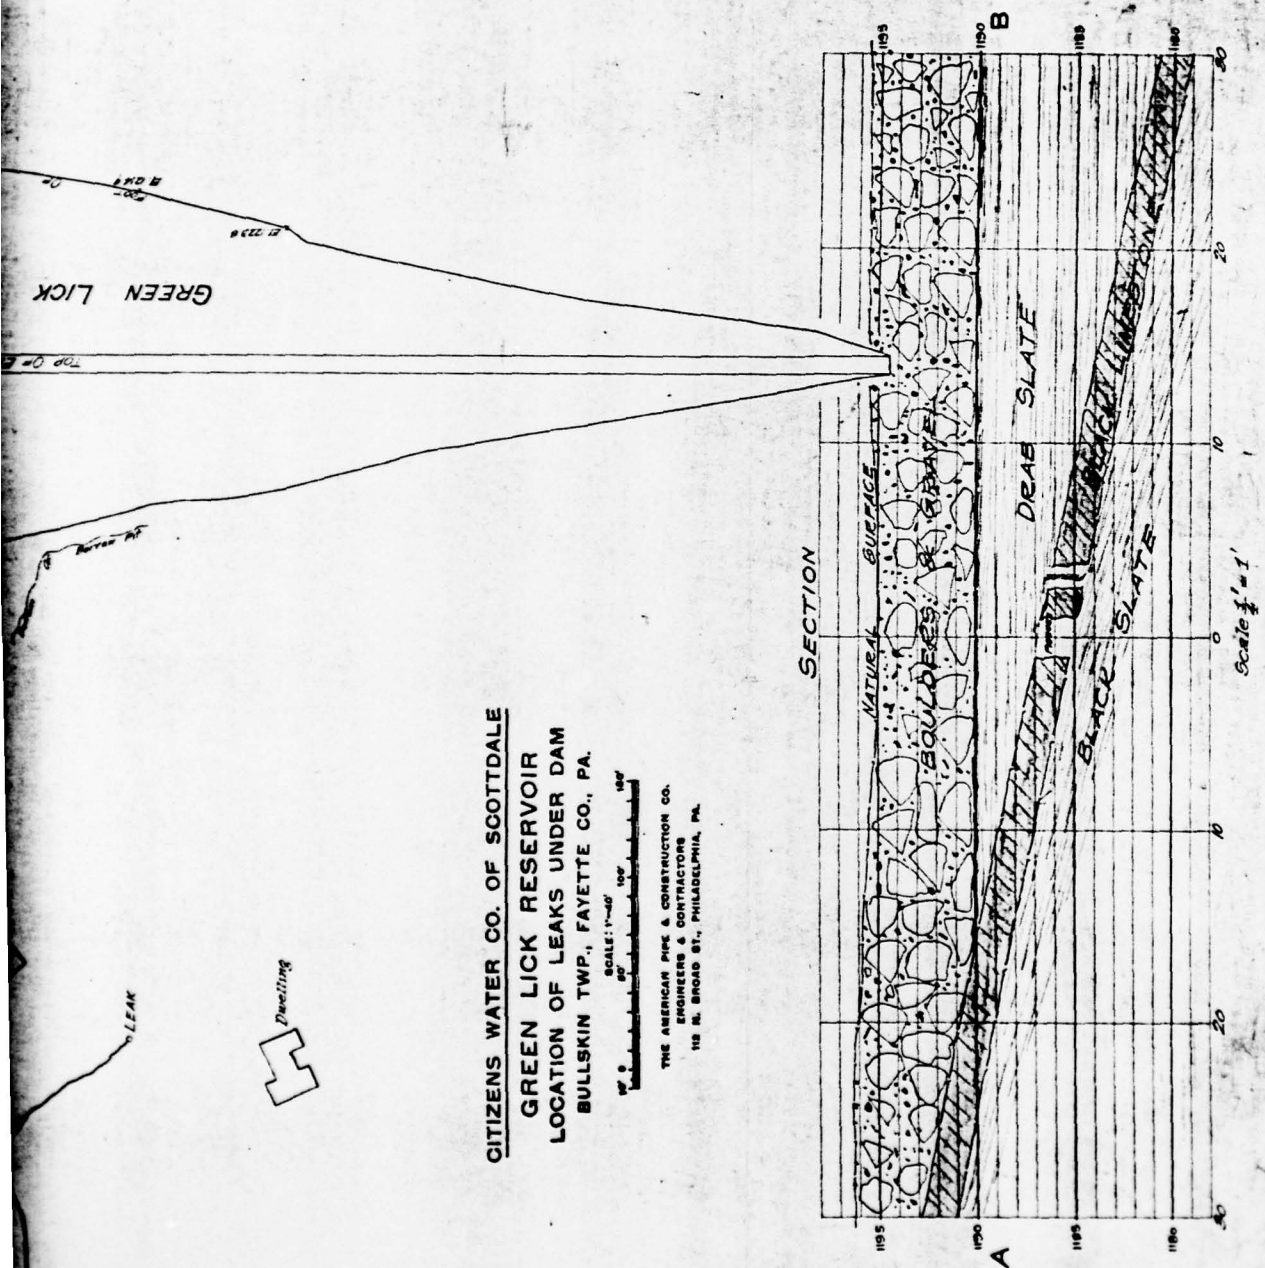
FIGURE 3

CITIZENS WATER CO. OF SCOTSDALE
GREEN LICK RESERVOIR
LOCATION OF LEAKS UNDER DAM
BULLSKIN TWP., FAYETTE CO., PA.
